⁽⁶⁾
METALLURGICAL CHANGES IN THE HIGH
TEMPERATURE FRETTING OF Ni and Ti
ALLOYS

⁽⁹⁾ Final Technical Report

⁽¹⁰⁾ R.B. Waterhouse and M.M. Hamdy

⁽¹¹⁾ February 1979

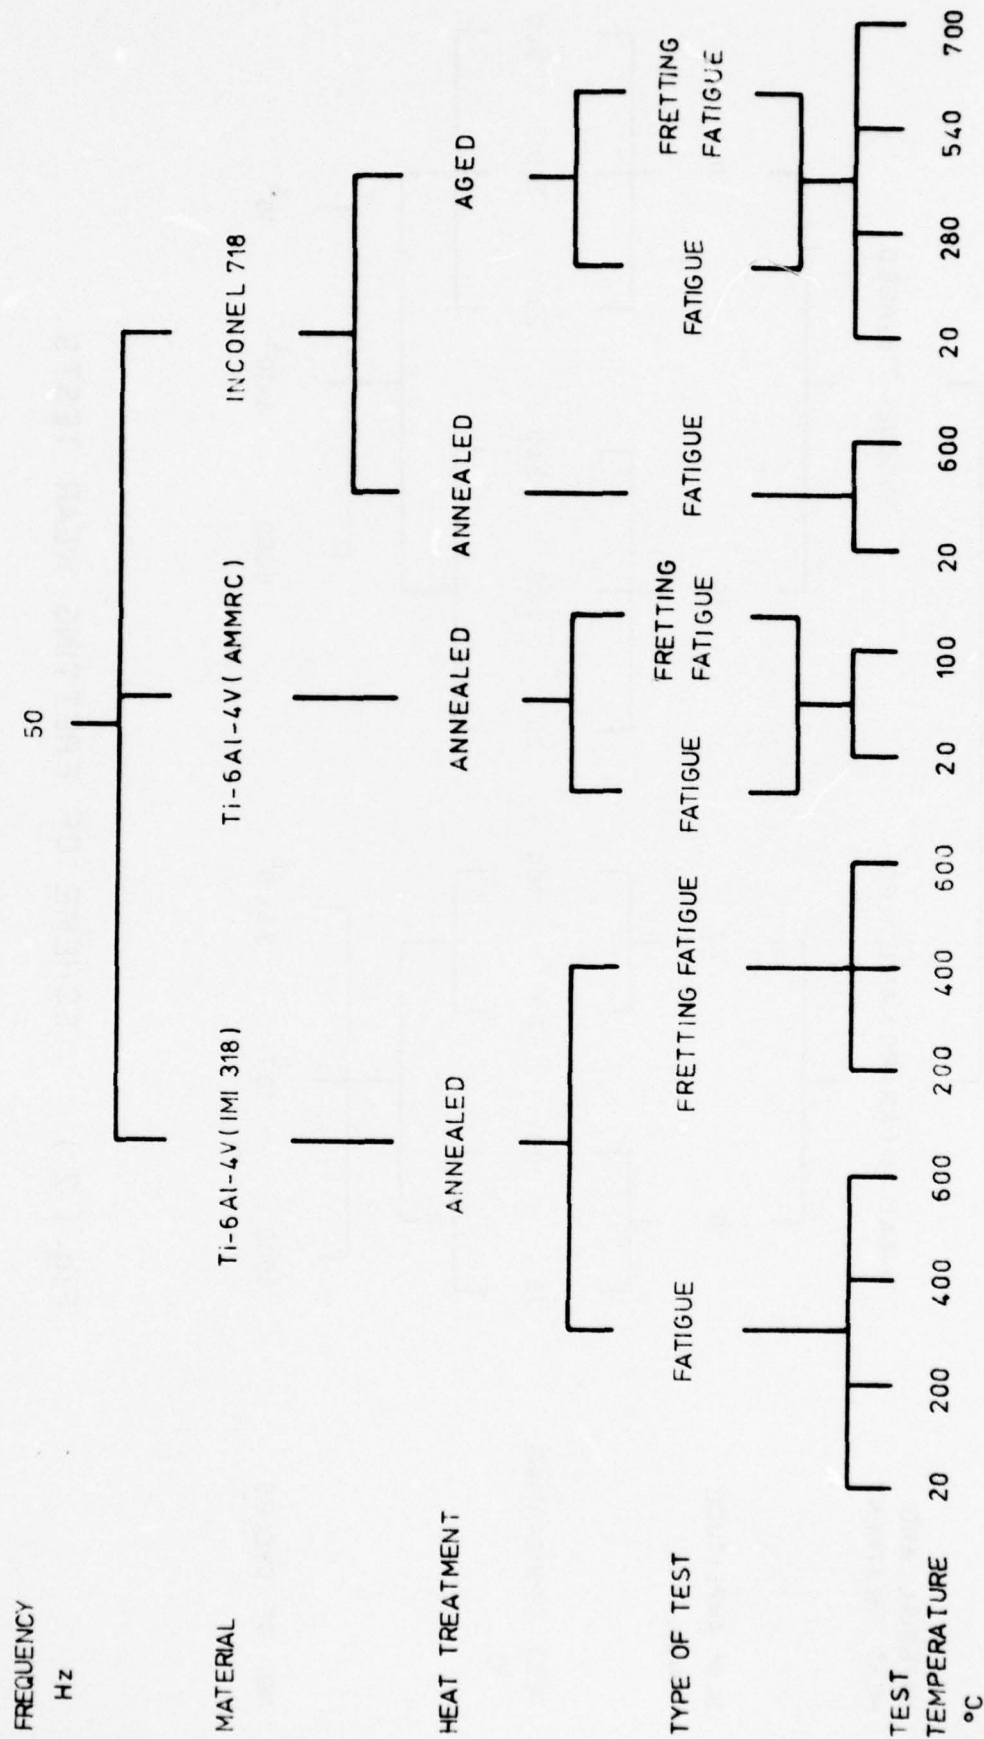
Fig. (1) FATIGUE AND FRETTING FATIGUE TESTS SCHEME .

fatigue and the fretting fatigue tests carried out. Details of the testing conditions are given in Table 1.

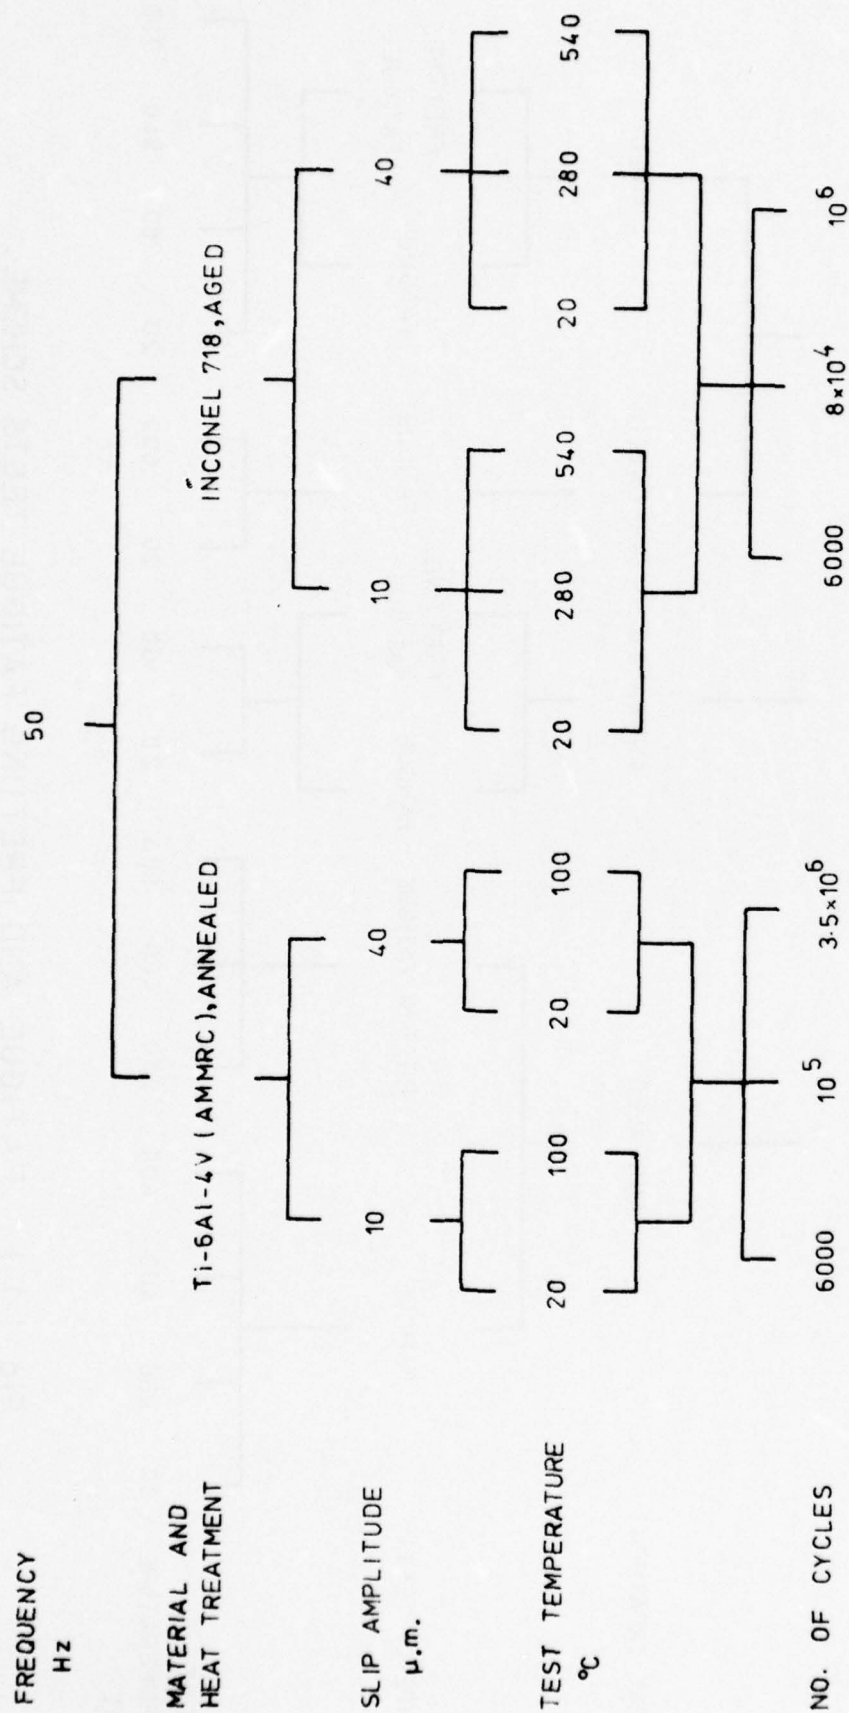
Fig. (2) SCHEME OF FRETTING WEAR TESTS.

The second series of tests is the fretting wear tests, details of which are shown in Fig. 2.

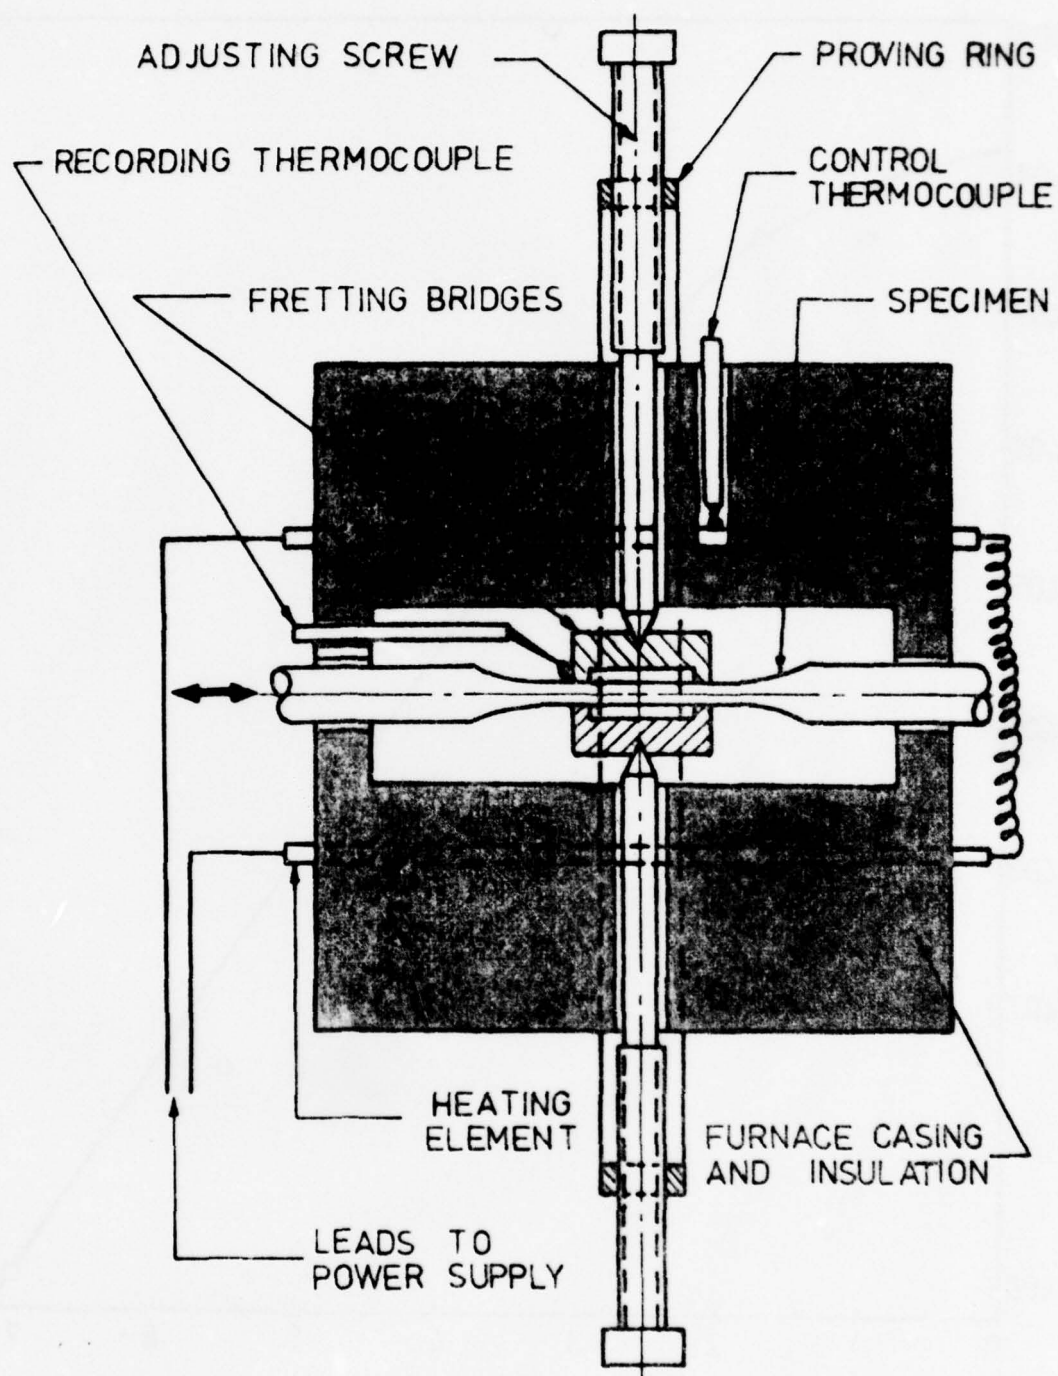
Fig. (3) PLAN VIEW OF FURNACE AND SPECIMEN
WITH FRETTING BRIDGES CLAMPED ON TO IT.

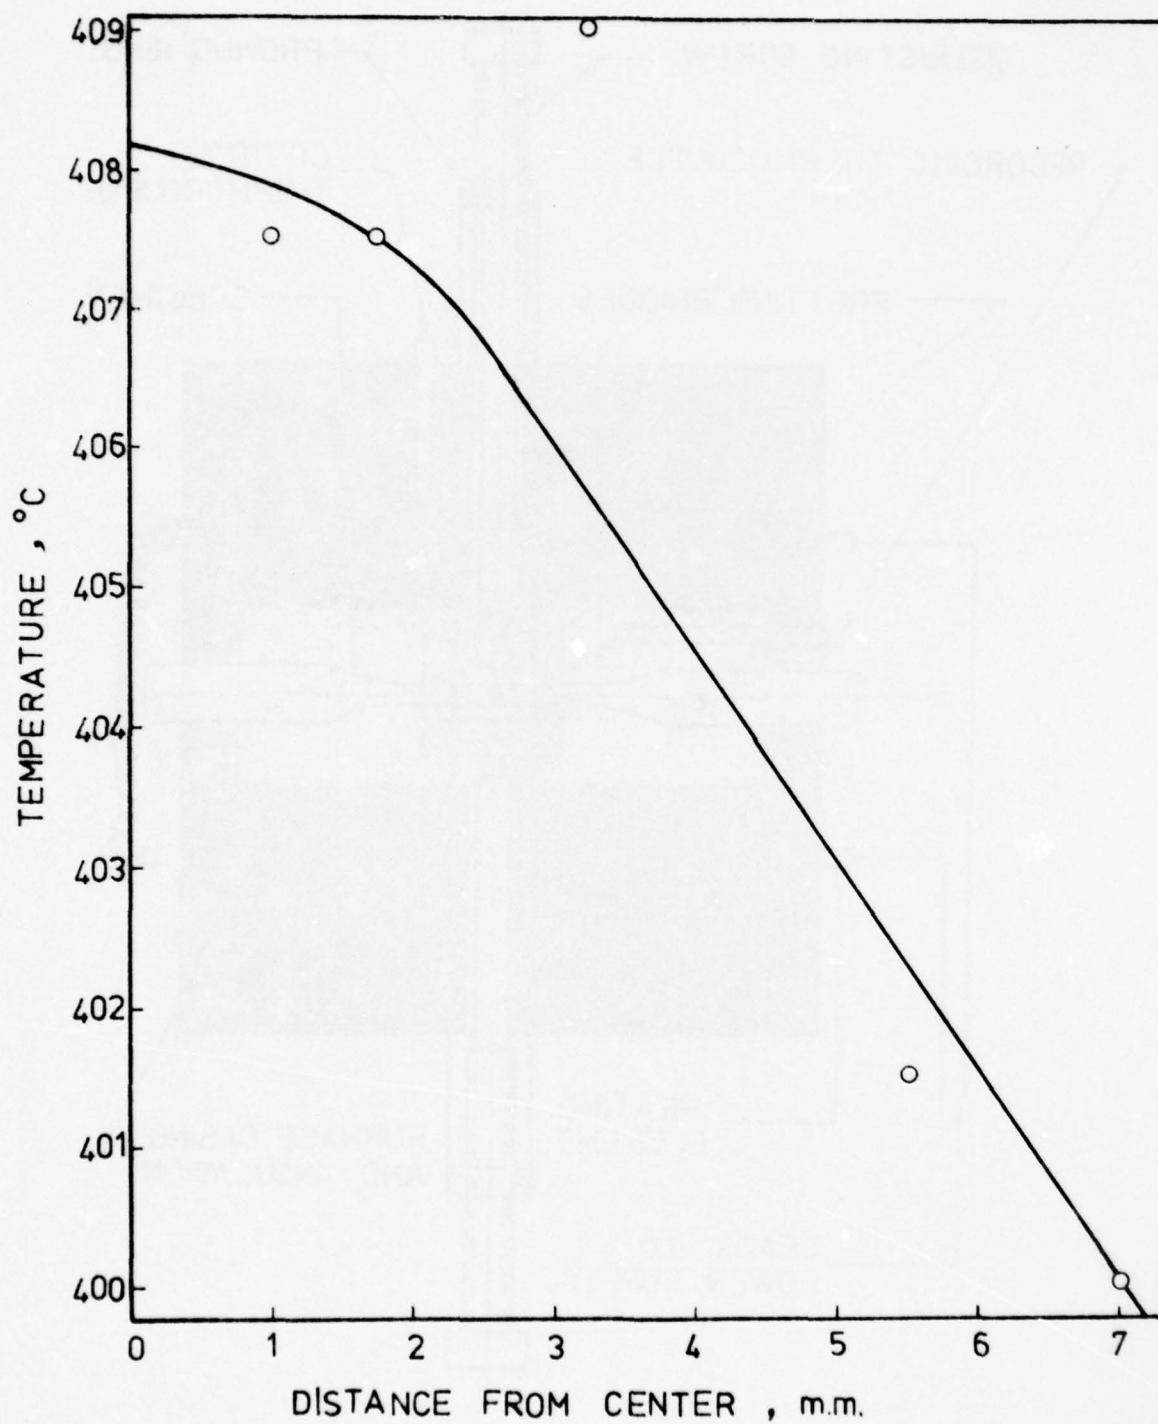
FIG.(4) TEMPERATURE DISTRIBUTION IN THE RADIAL DIRECTION.

Initially, the furnace main outside body was made from sindanyo (heat insulating material) backed with heat insulating wool, while the inside surface and the two flat faces of each half of the furnace were made of stainless steel sheet. Careful temperature surveys in both longitudinal and radial directions revealed that at 600 C there was a variation of 34 C over the gauge length of the specimen. Relocation of the heating elements and replacement of the two stainless steel panels by sindanyo panels has reduced the temperature variation over the gauge length to within 3 C at 600 C. Figures 4 to 7 show the results of the temperature surveys after improvement.

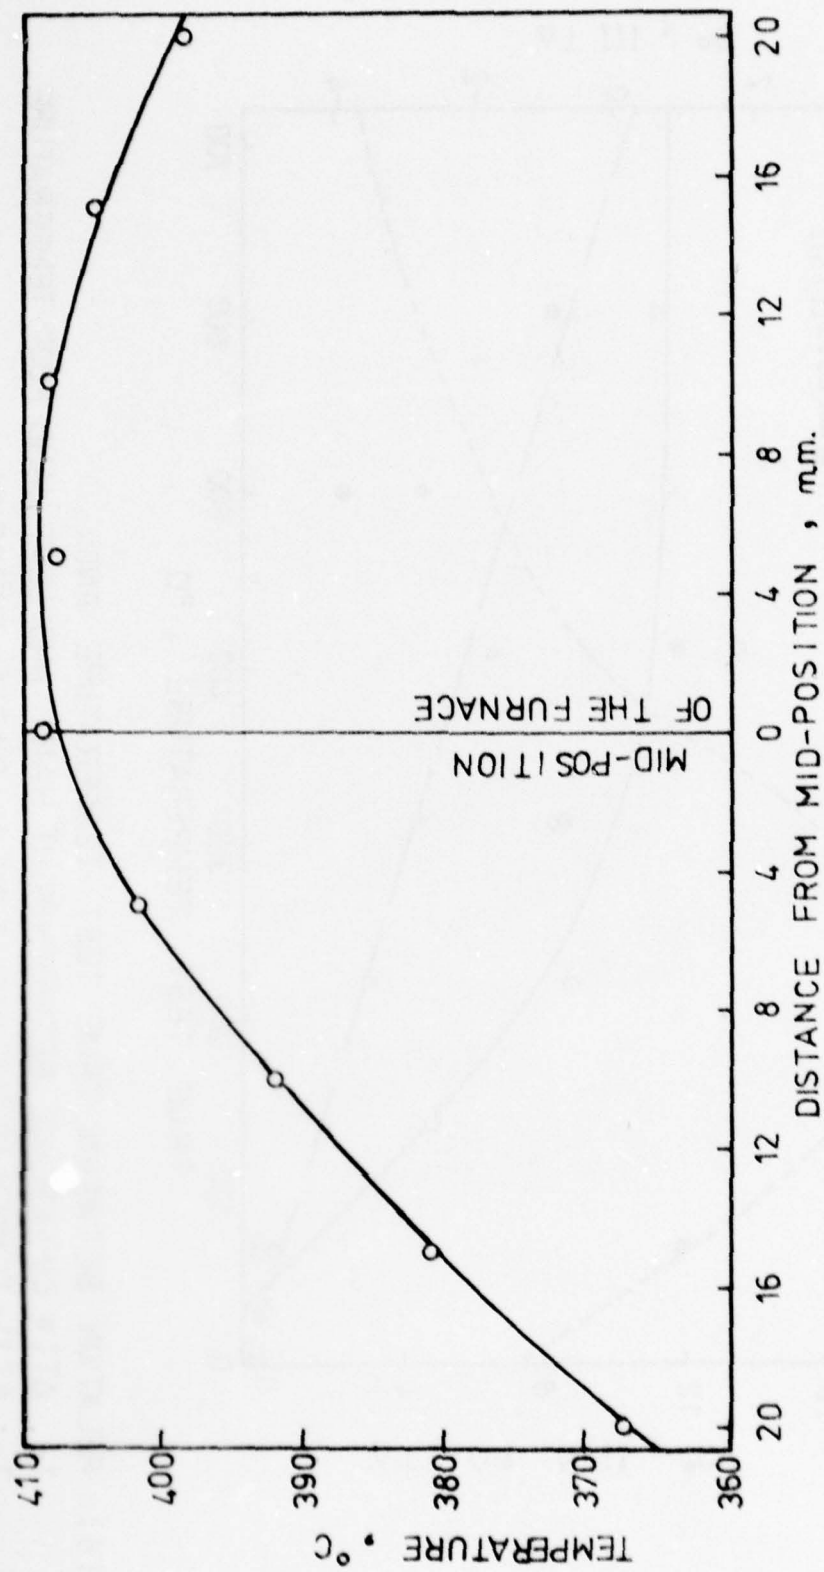
FIG.(5) TEMPERATURE DISTRIBUTION IN THE LONGITUDINAL DIRECTION.

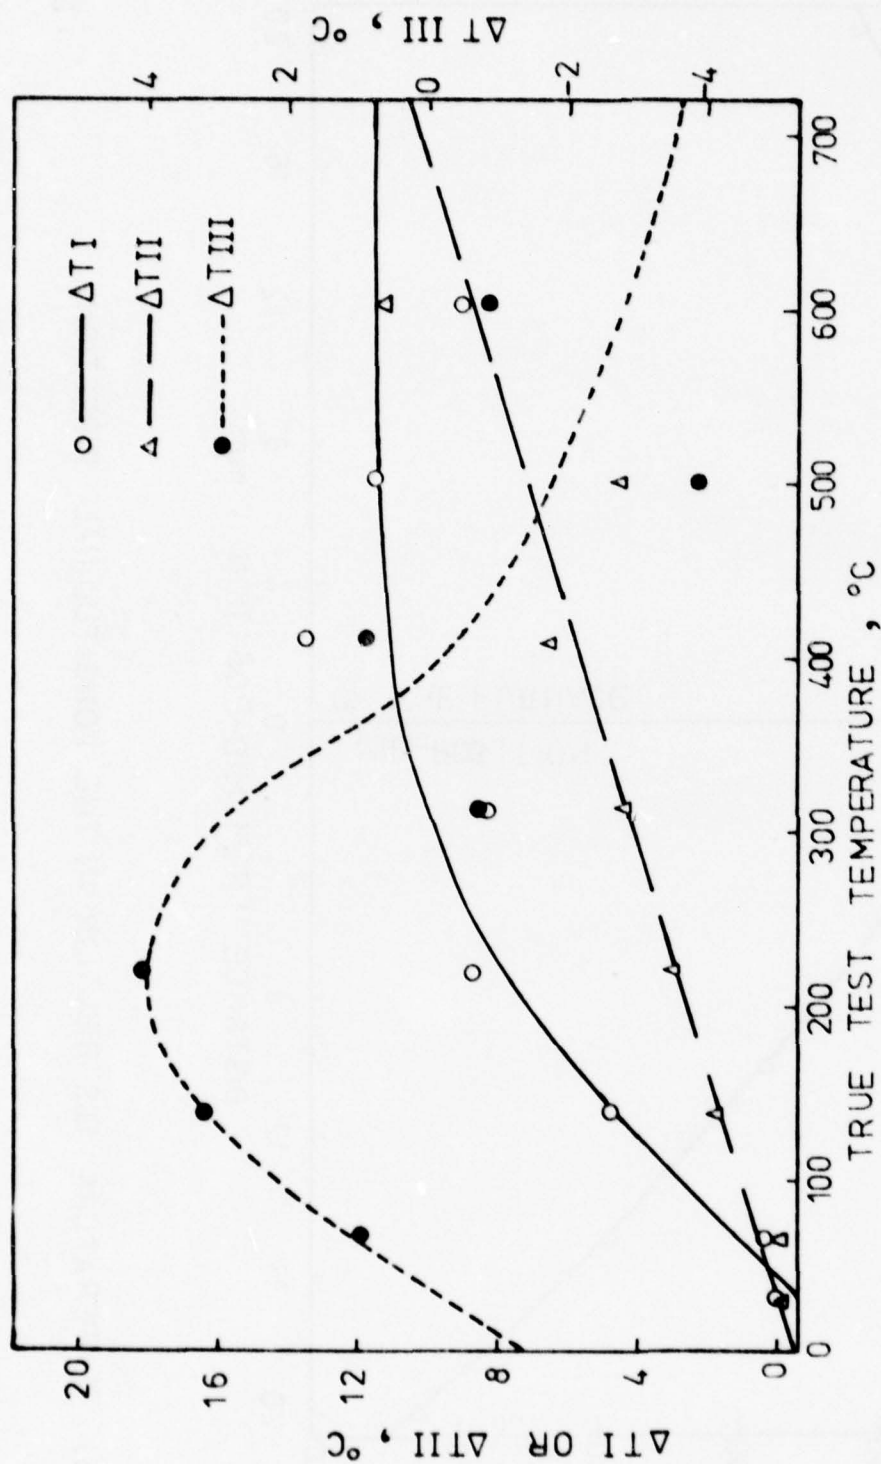
FIG.(6) RELATION BETWEEN TRUE TEST TEMPERATURE AND:

- 1- $\Delta T I$ = DIFFERENCE BETWEEN RIGHT HAND AND LEFT HAND FOOT TEMPERATURE.
- 2- $\Delta T II$ = TEMPERATURE VARIATION IN RADIAL DIRECTION.
- 3- $\Delta T III$ = DIFFERENCE BETWEEN RADIAL AND LONGITUDINAL TEMPERATURE.

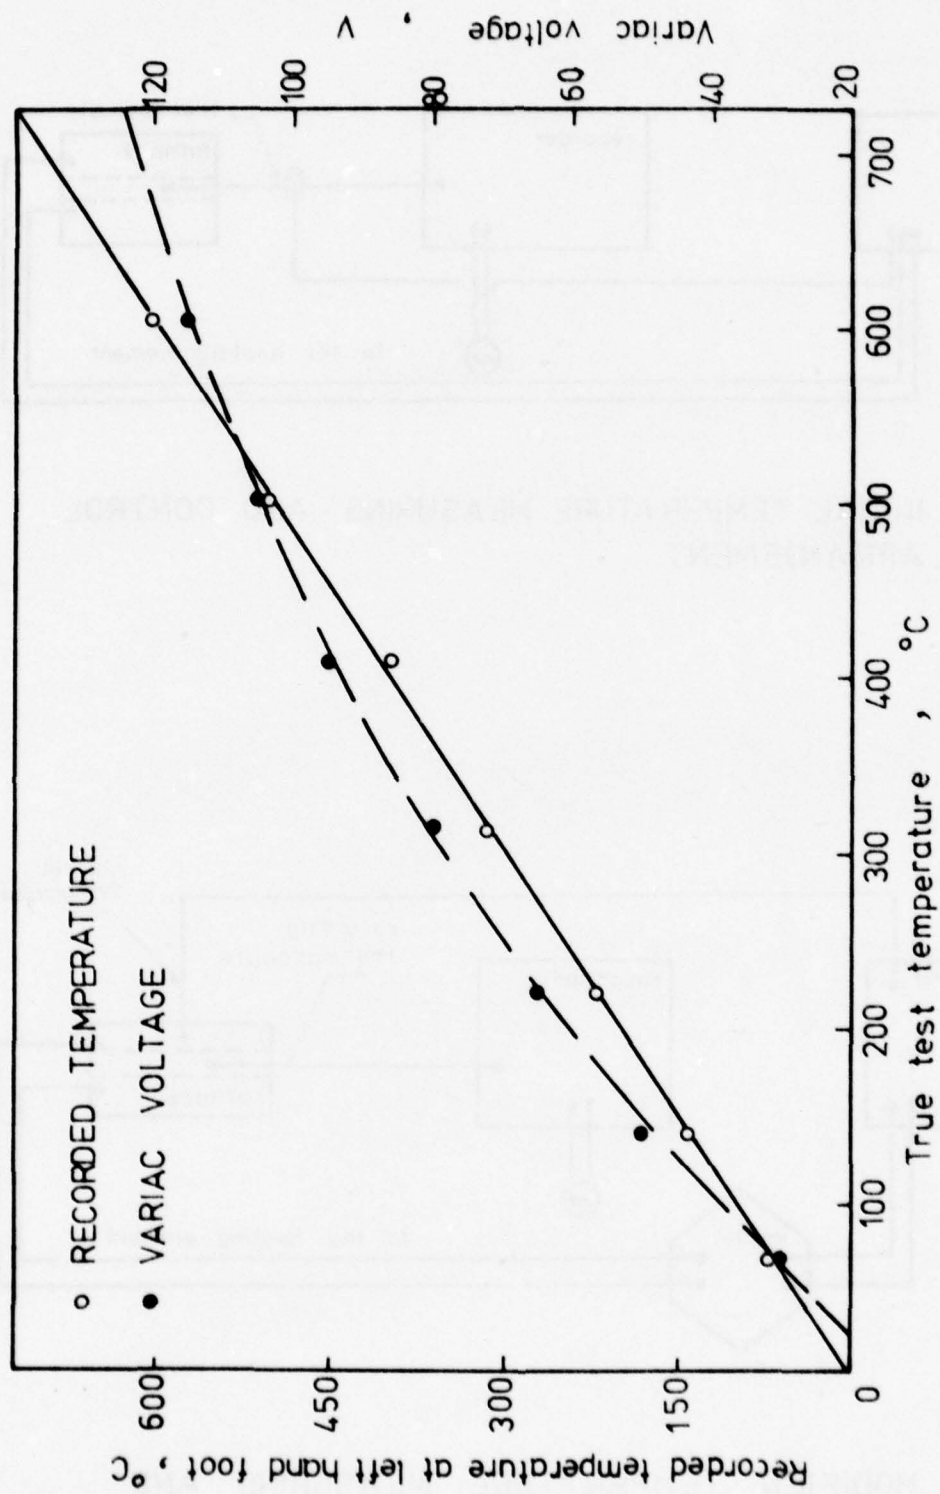
FIG.(7) Relation between true test temperature and recorded temperature at left hand foot of the bridge and the suitable variac voltage .

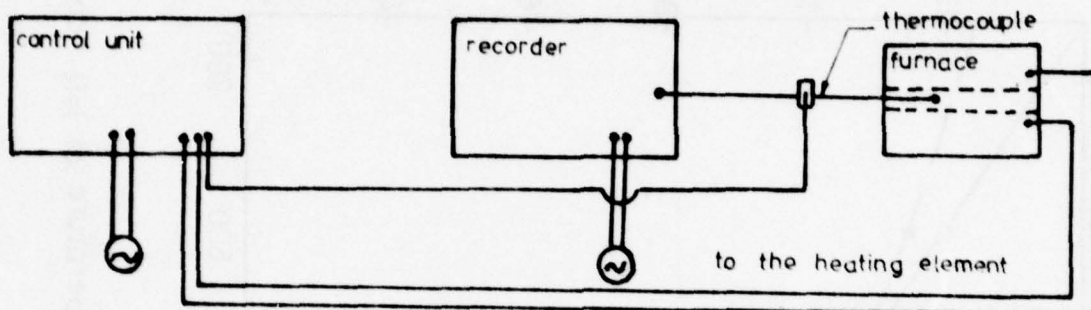
FIG.(8) INITIAL TEMPERATURE MEASURING AND CONTROL ARRANGEMENT.

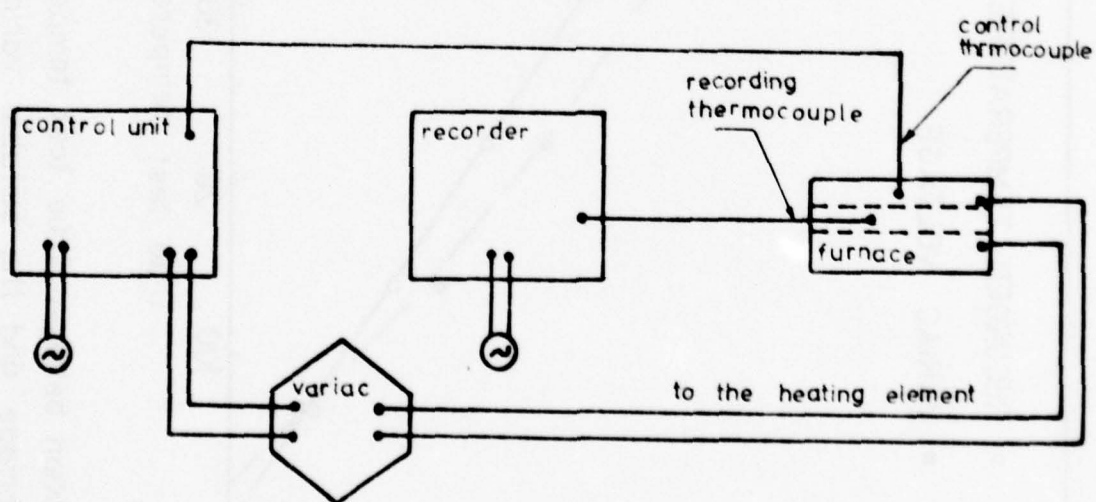
FIG.(9) MODIFIED TEMPERATURE MEASURING AND CONTROL ARRANGEMENT.

The modified temperature measuring and control arrangement described before in Section 3.2.3 and shown graphically in Figure 9 was used in the high temperature fretting wear tests. The control thermocouple was located inside the fretting wear furnace with its hot junction as near as possible to the heating element, while the recording thermocouple was located with its hot junction as near as possible to the contact point between the rider and the flat specimen.

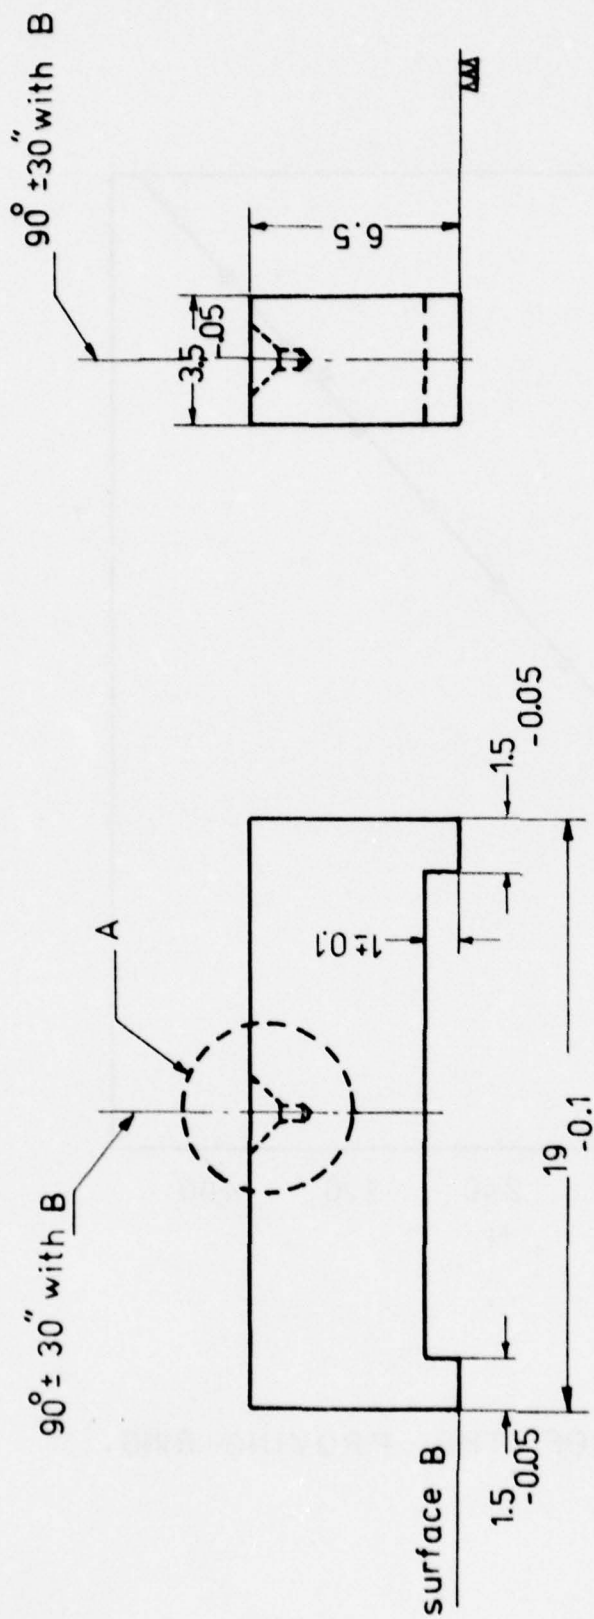
Details of A (Scale 10:1)

Scale 5:1 (10:1)
Dimensions in millimeters

FIG.10 FRETTING FATIGUE BRIDGE .

The fretting fatigue device is shown in Plate 3. The fretting was produced by clamping a pair of bridge pieces 19 mm in length and 3.5 mm wide, each having two feet of dimension 1.5 x 3.5 mm (Figure 10) which were machined from the same material as the specimen and had the same heat treatment condition, and were given the same surface finish on the gauge length of the specimen. The bridges were clamped on to the prepared flats of the specimen by means of a proving ring. The clamping load was applied by means of screwed prongs along one diameter of the ring and measured by the resulting contraction of the perpendicular diameter. Steel balls pressed into the outside of the ring at either end of this perpendicular diameter served as measuring points for a micrometer. Plate 3 shows the proving ring with the prings holding the bridges on to the specimen.

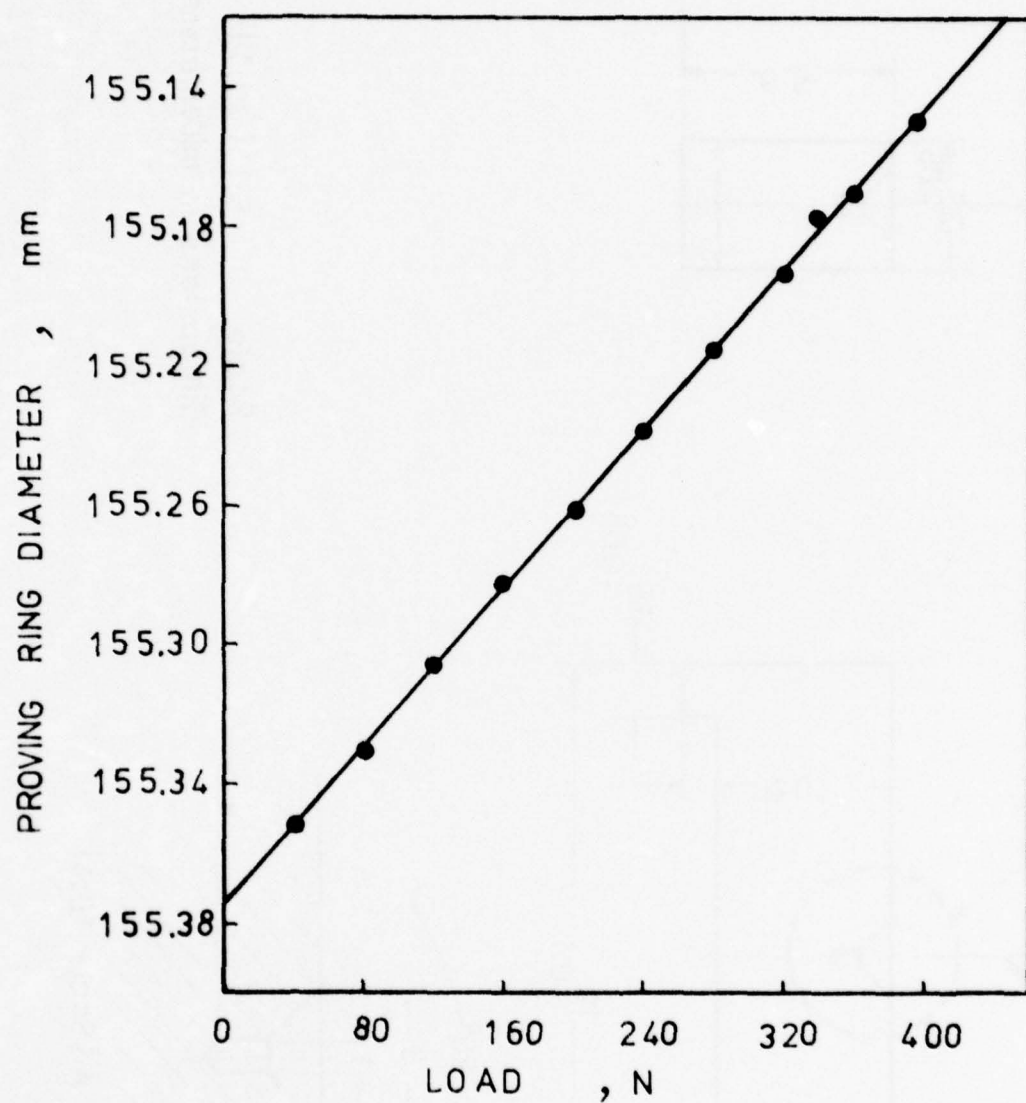
FIG. 11 CALIBRATION OF THE PROVING RING.

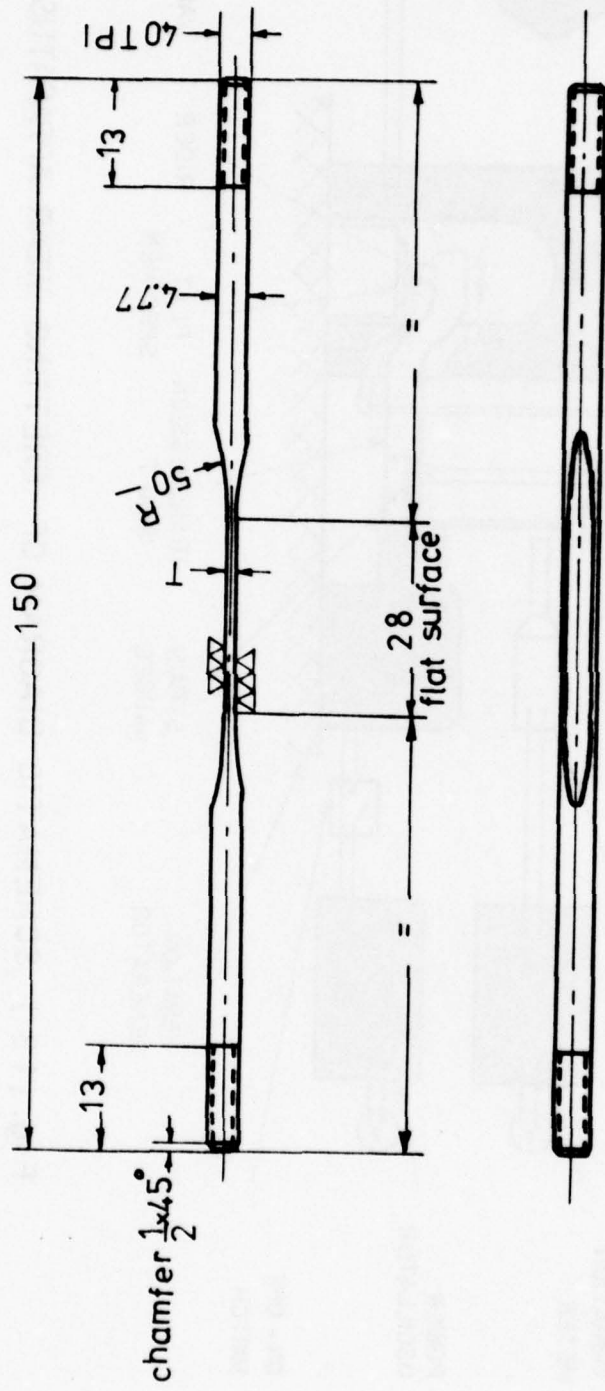
Scale : 1:1
 Dimensions: in millimeters

FIG. 12 FATIGUE AND FRETTING FATIGUE SPECIMENS.

- 1.56 mm for all Ti-6Al-4V (IMI 318) fretting fatigue specimens and 600 C fatigue specimens,
- 0.7 mm for Ti-6Al-4V (IMI 318) fatigue specimens tested at room temperature, 200 C and 400 C,
- 0.8 mm for Ti-6Al-4V (AMMRC) fatigue and fretting fatigue specimens,
- 0.5 mm for all tests conducted on Inconel 718 alloy (aged condition),
- 1.6 and 1 mm for all tests conducted on Inconel 718 alloy (annealed condition).

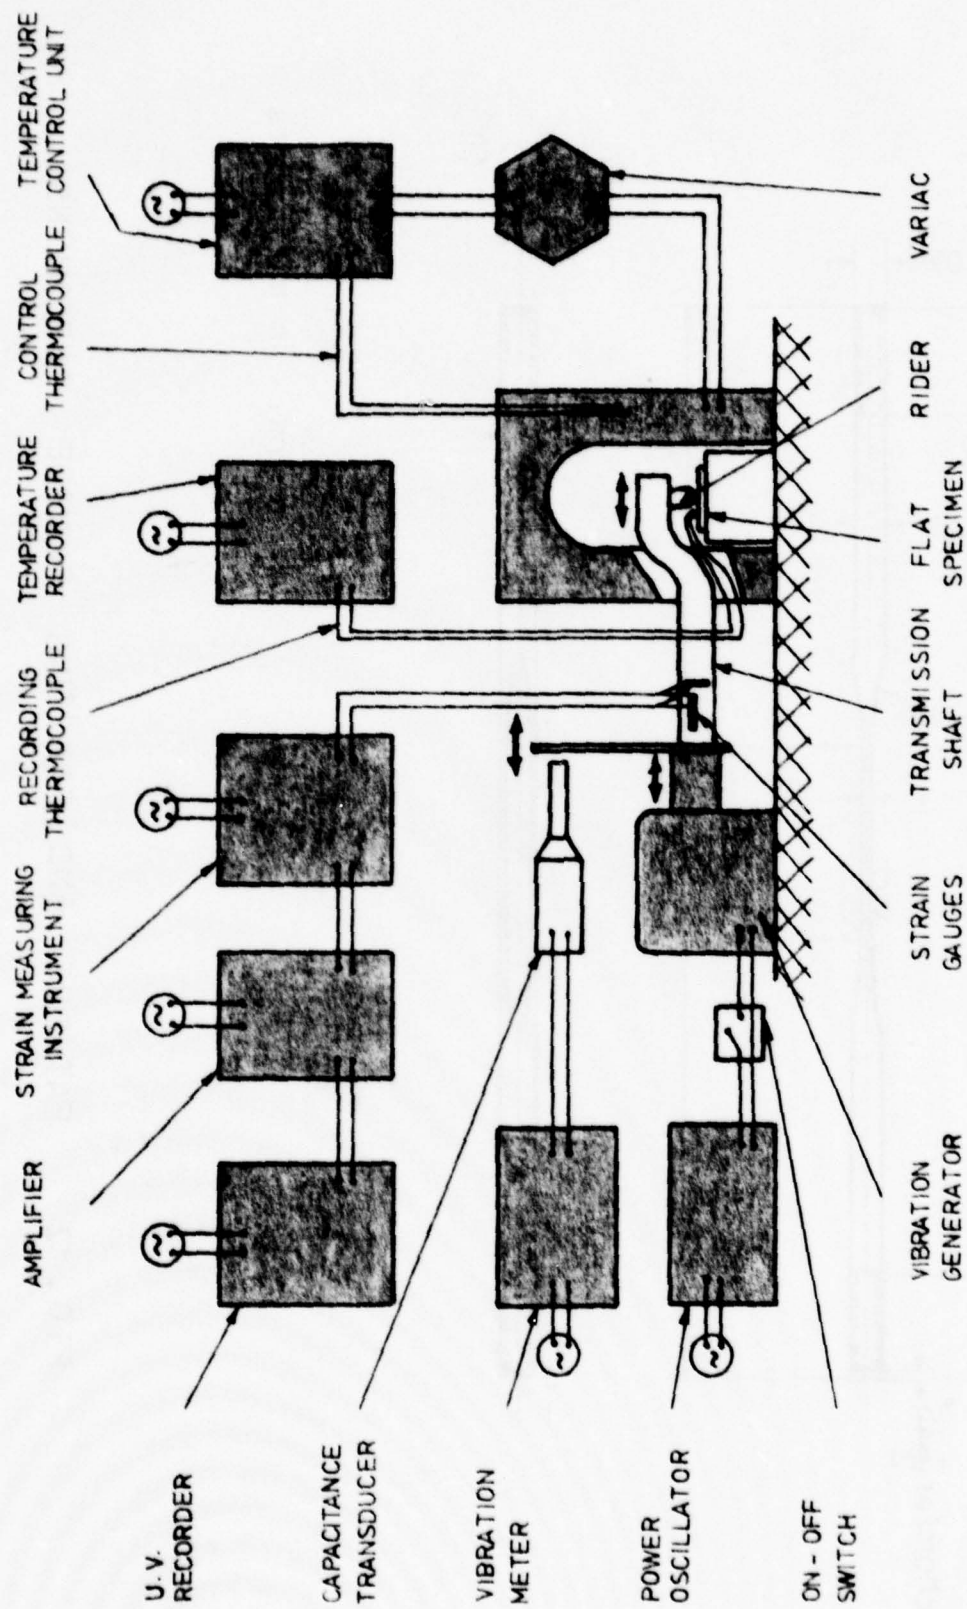
Fig. (13) SCHEMATIC DIAGRAM OF FRETTING WEAR APPARATUS.

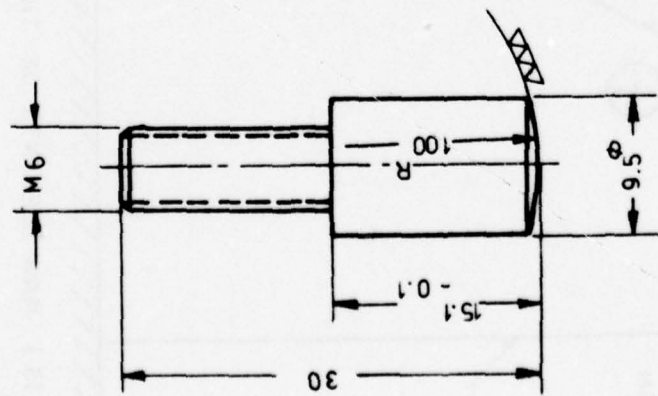
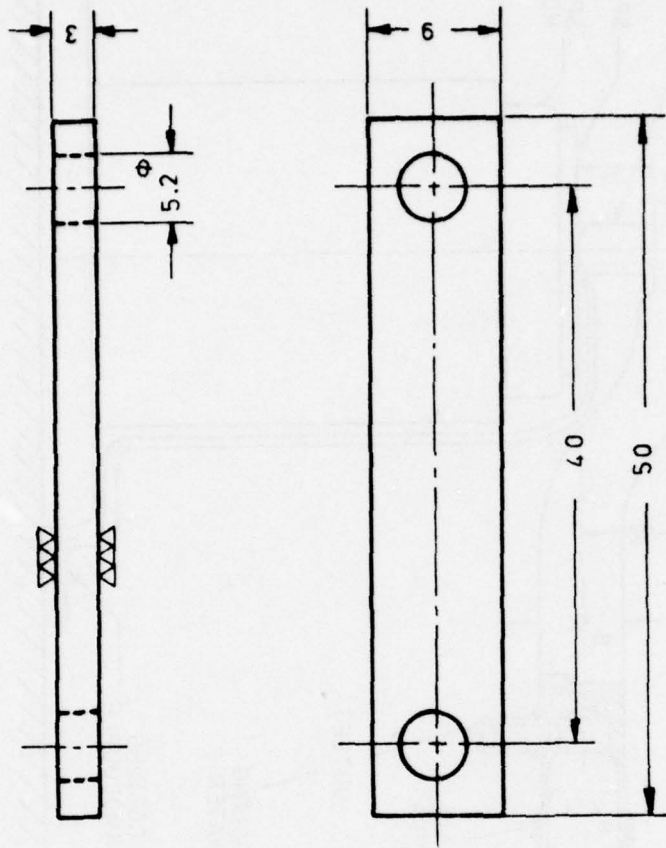
BREAK SHARP CORNERS
DIMENSIONS IN MILLIMETERS
SCALE: 2 : 1

Fig. (14) RIDER AND FLAT SPECIMEN .

It was decided to fret a spherical rider against a stationary flat plate specimen of the same material, with the same heat treatment condition, and the same surface finish. The oscillatory motion of the rider was parallel to the polishing direction of the flat specimen, i.e. parallel to the longitudinal direction of the flat specimen.

The flat plate specimen was machined from 9.5 mm diameter rod and was 50 mm long, 9 mm wide and 3 mm thick. It had two holes drilled in it to fix it in the stainless steel support.

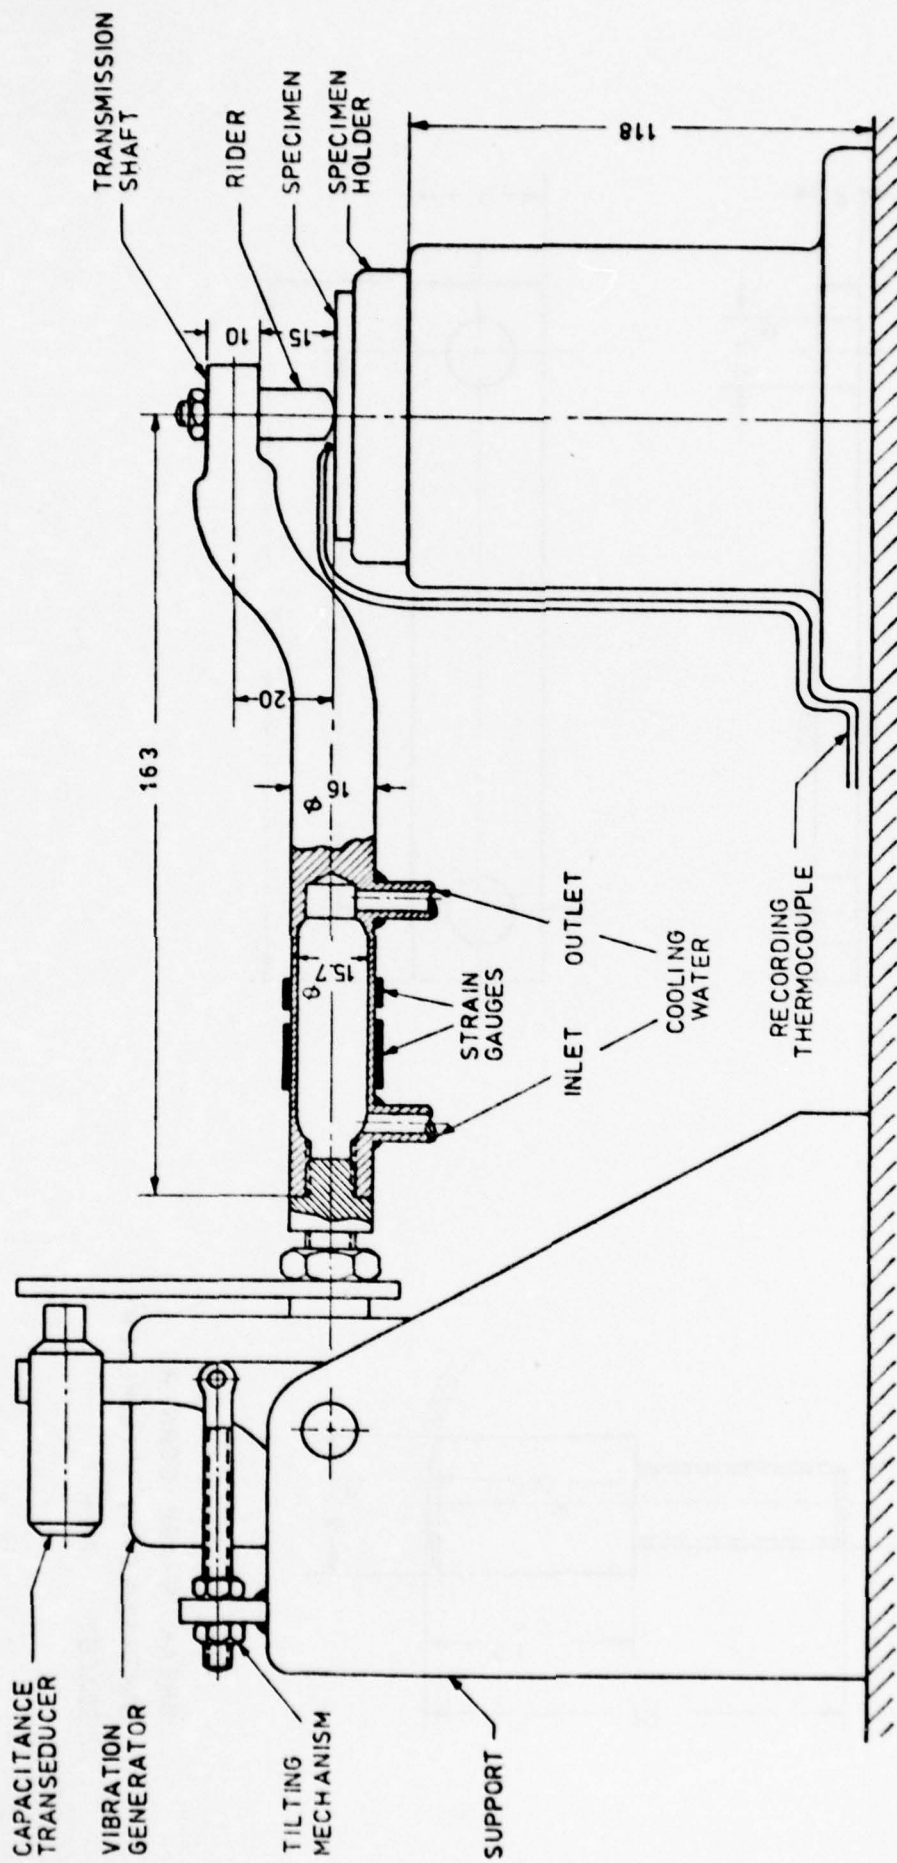
Fig. (15) MAIN ELEMENTS OF THE OSCILLATING MOVEMENT SYSTEM WITH THE MAIN DIMENSIONS .

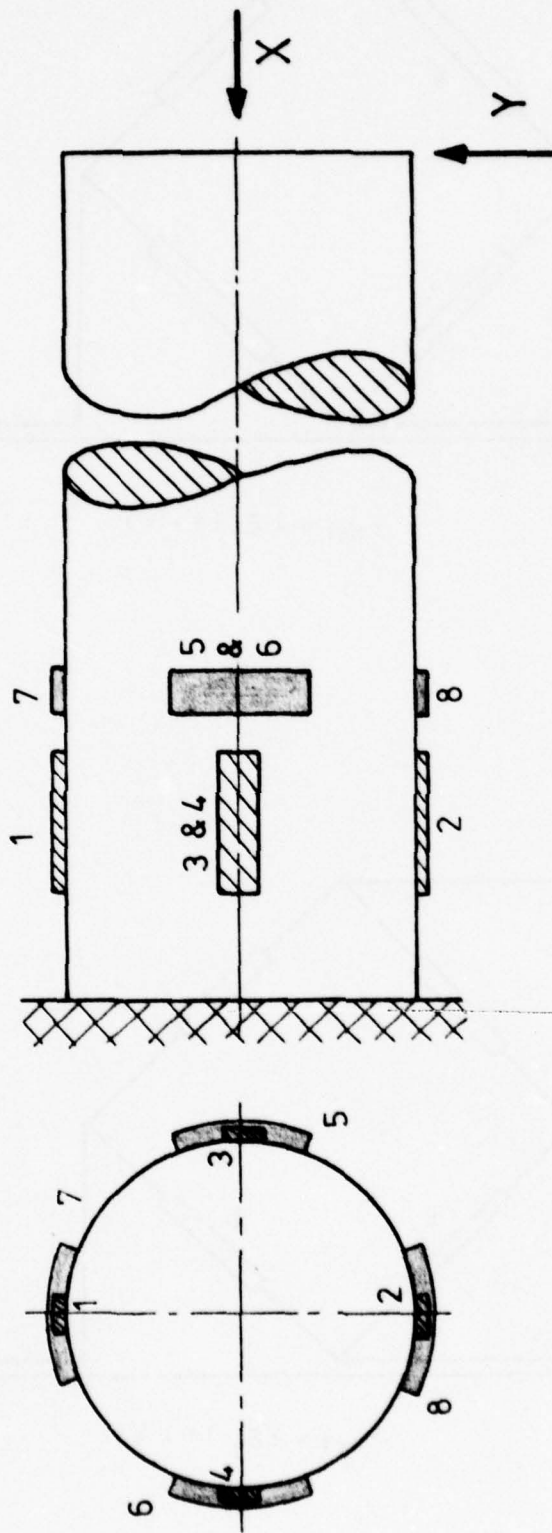
Fig. (16) RELATIVE POSITIONS OF STRAIN GAUGES ON THE SHAFT.

The transmission shaft was hollow to allow cooling water to pass through it so as to avoid overheating of the shaft and the strain gauges. It reduced the shaft cross-sectional area in the strain gauged zone which allowed measurement of very small forces. Because one end of the shaft was inserted inside the furnace, it was made of stainless steel.

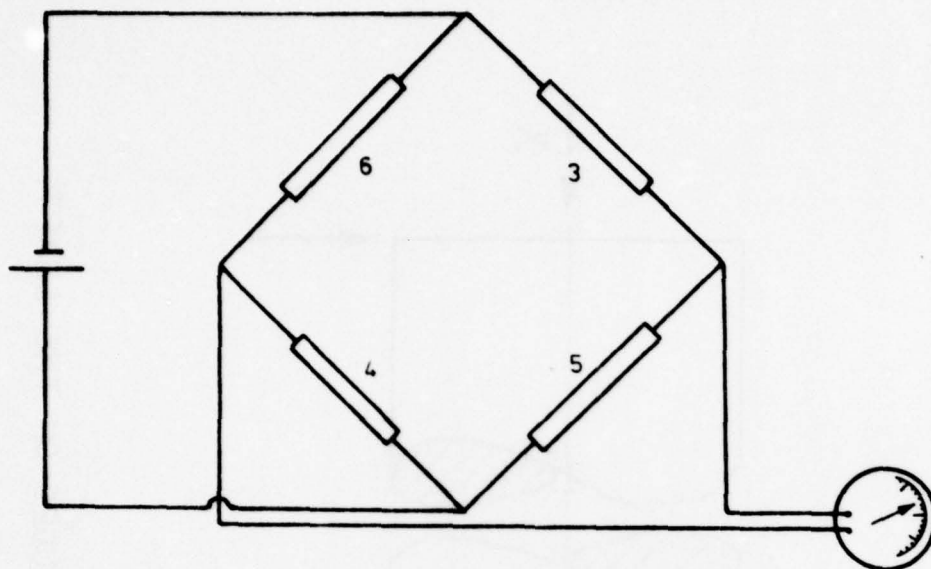
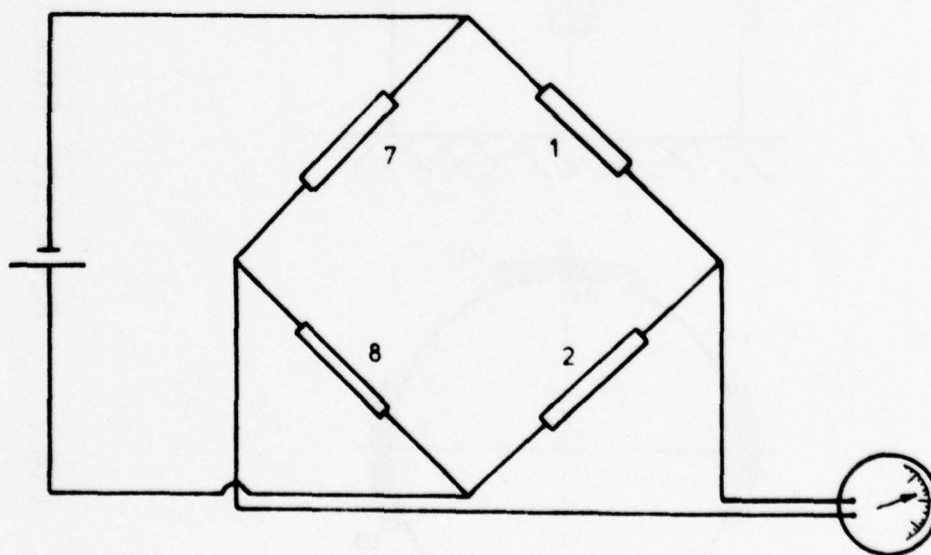
$$E_{net} = 2 E_x (1 + \nu)$$

$$E_{net} = 2 E_y (1 + \nu)$$

Fig. (17) STRAIN GAUGES CIRCUITS FOR MEASURING: A-FRICTION FORCE, B-NORMAL FORCE.

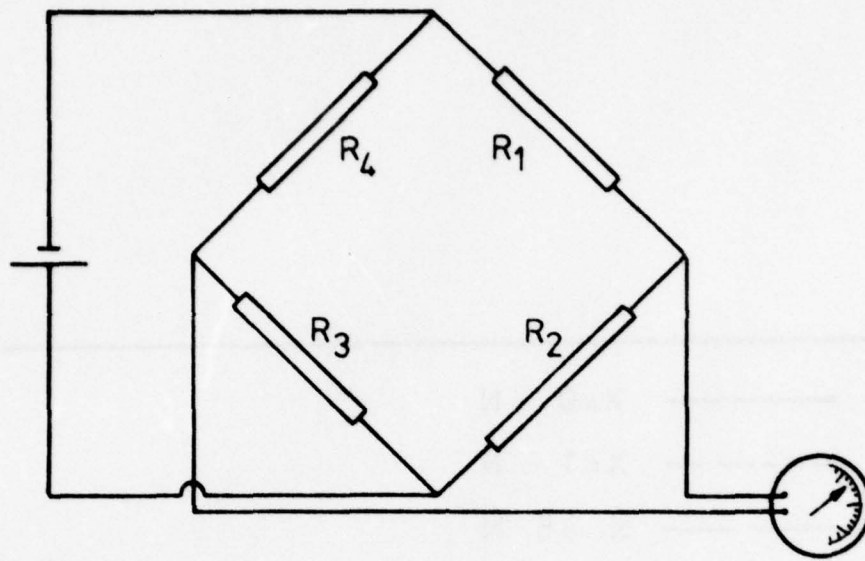
Fig.(18) FULL BRIDGE STRAIN GAUGES CIRCUIT.

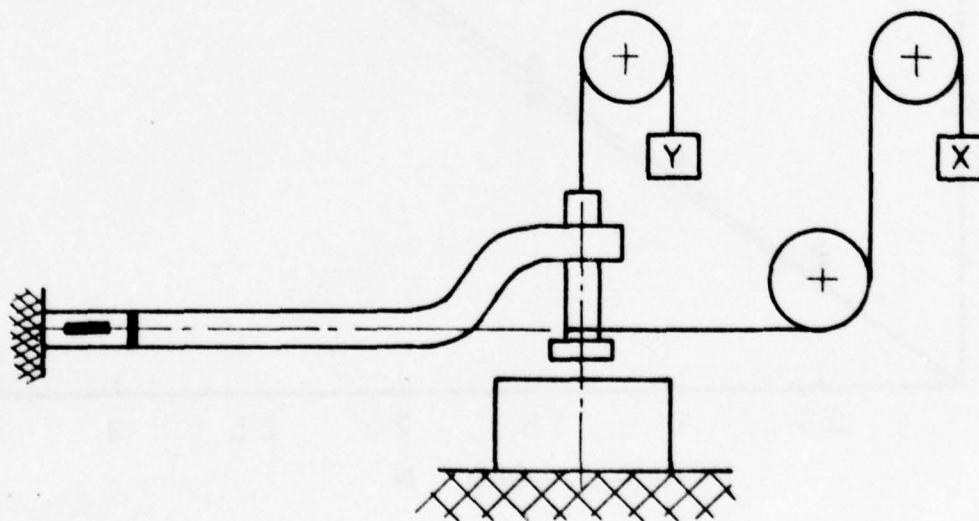
Fig. (19) ARRANGEMENT FOR CALIBRATING THE NORMAL AND FRICTION FORCES.
